INITIAL SITE INVESTIGATION REPORT

SMM REALTY

262 Main Street
Winooski, VT

29 June, 1998

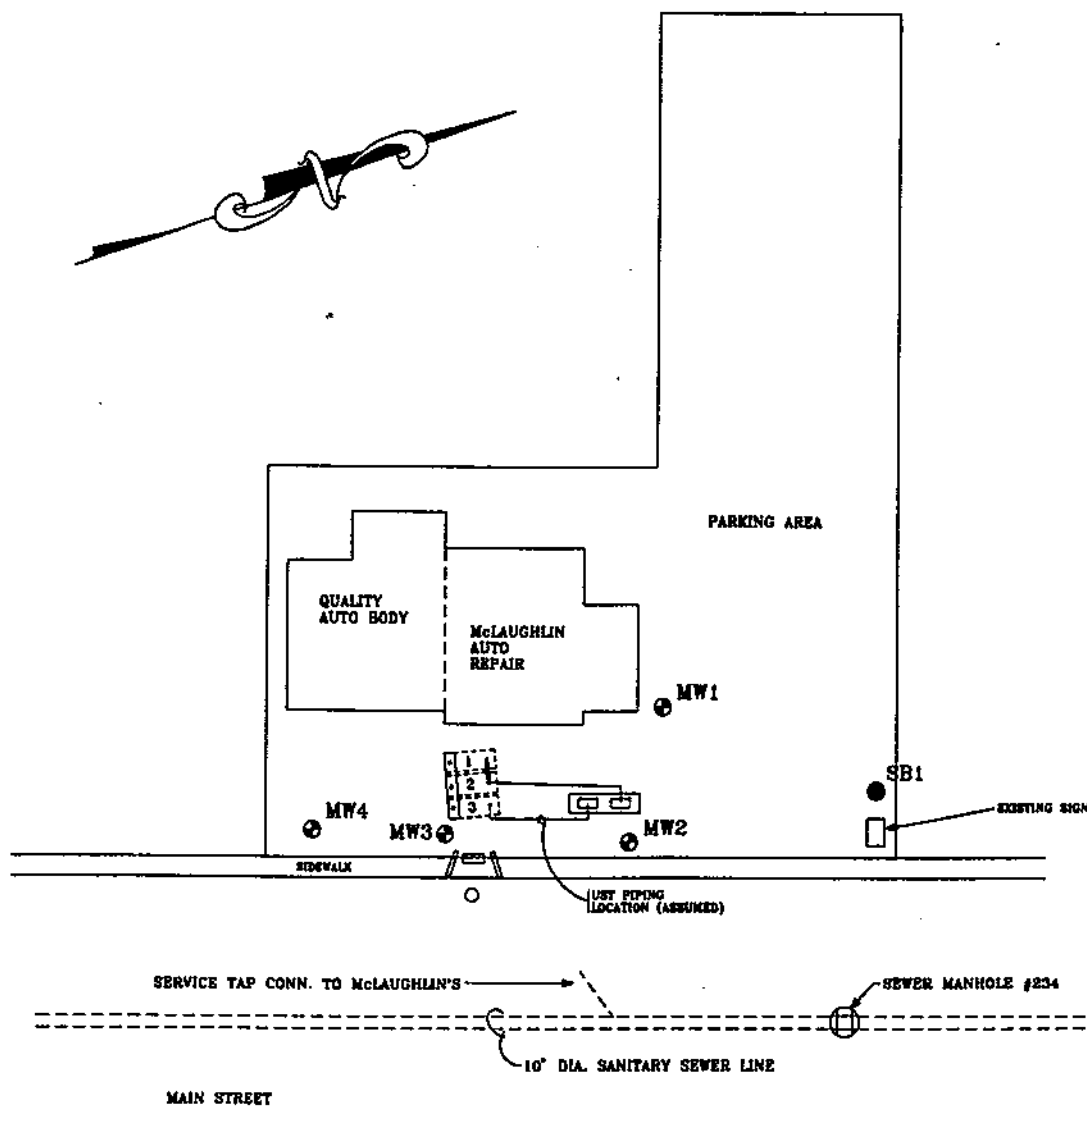
- 1) Site Location Map**
- 2) Site Map**
- 3) Groundwater Contour Map**

On December 6, 1994, four groundwater monitoring wells (MW-1, MW-2, MW-3 and MW-4) and one soil boring (SB-1) were drilled to further determine the extent and degree of subsurface contamination at McLaughlin's Auto Repair. The locations of the wells and soil boring are displayed on the site map in Appendix A. The locations of the monitoring wells and the soil boring were chosen based on the assumption that the suspected petroleum contamination was located in the vicinity of the USTs and pump island. Wells were placed both upgradient and downgradient of the tanks and piping to surround the suspected area of contamination. A soil boring was not drilled on the west side of the USTs, however, due to limited space, and to avoid the possibility of damaging the underground sewer service connection to the building.

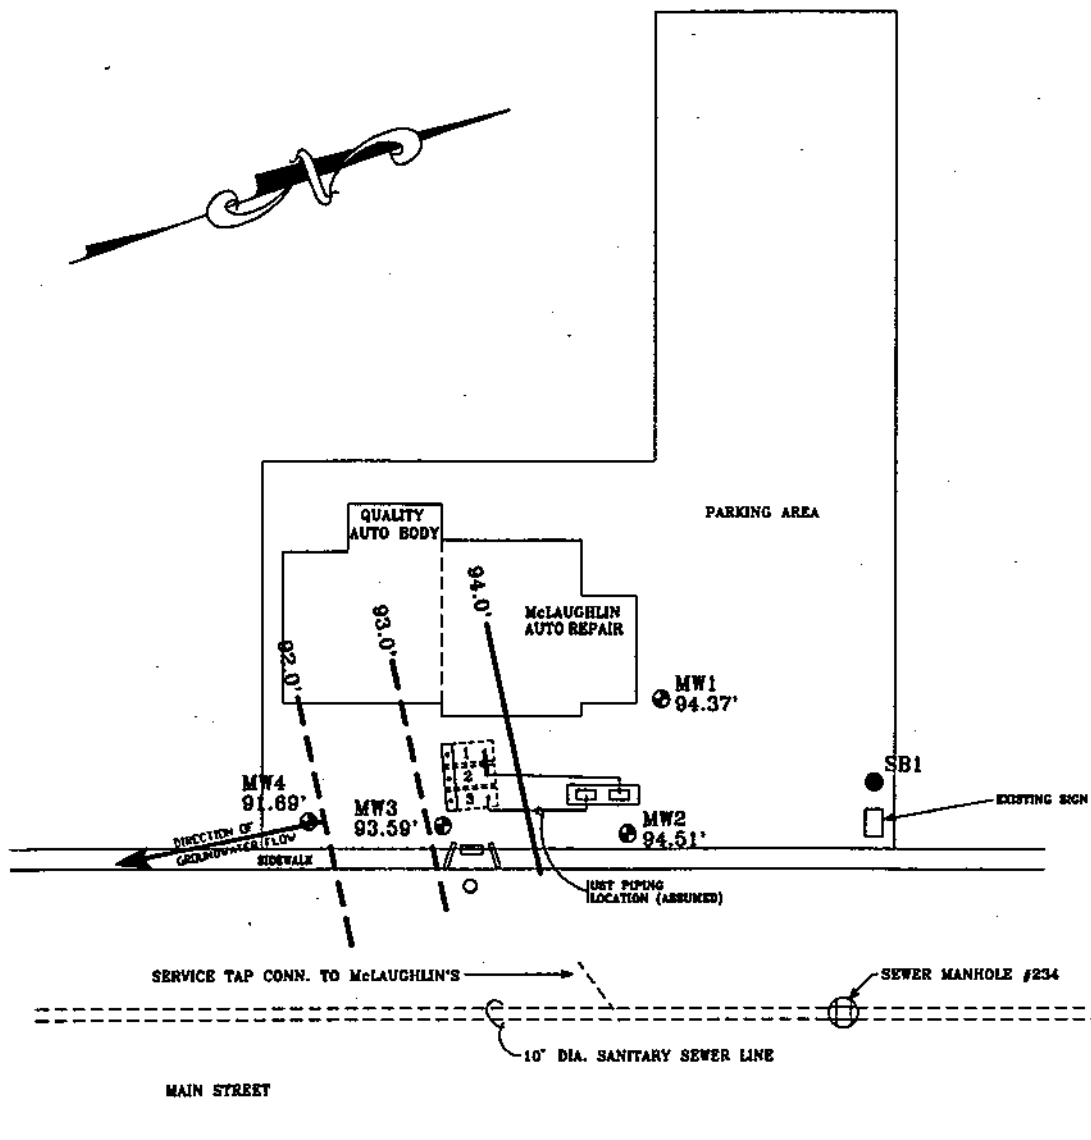
Immediately following the collection of groundwater elevation data, samples of the groundwater were collected from three of the four monitoring wells at McLaughlin's Auto Repair (MW-2, MW-3, and MW-4). A sample was not collected from MW-1 as not enough water was present in the well. Free floating petroleum product was not observed in any of the monitoring wells. All samples were analyzed for benzene, toluene, ethylbenzene, and xylenes (BTEX), common constituents found in petroleum products, and MTBE, a common gasoline additive, per EPA Method 602. Results of the laboratory analyses for those wells sampled on this date are summarized in Appendix B at the end of this report.

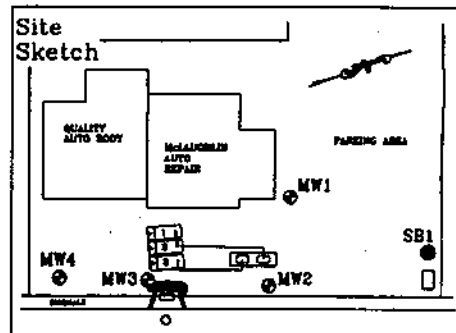
WELL NUMBER SB1

DEPTH IN FEET	WELL CONSTRUCTION	NOTES	BLOWS PER 6" OF SPOON & PID READINGS	DESCRIPTION/SOIL CLASSIFICATION (COLOR, TEXTURE, STRUCTURES)	DEPTH IN FEET
0

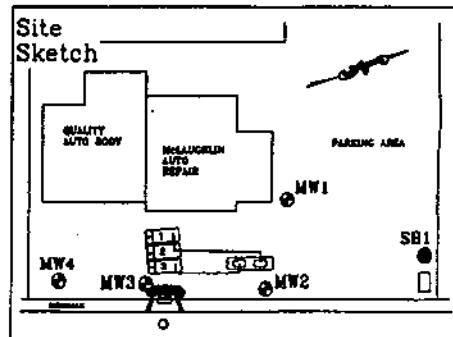
WELL NUMBER MW1

DEPTH IN FEET	WELL CONSTRUCTION	NOTES	BLOWS PER 6" OF SPOON & PID READINGS	DESCRIPTION/SOIL CLASSIFICATION (COLOR, TEXTURE, STRUCTURES)	DEPTH IN FEET
0	ROAD BOX LOCKING WELL CAP				0
1	CONCRETE		0'-2'- 2,1,1,2 15.8 ppm	Light brown silty SAND and GRAVEL, moist, no petroleum odor.	1
2	BENTONITE				2
3	WELL RISER		2'-4'- ham,1ham,1 2.0 ppm	Surface gravel with silty SAND (fill).	3
4	SAND PACK				4
5	WELL SCREEN		4'-6'- 1,1,1,4 11.6 ppm	5.0' WATER TABLE	5
6	BOTTOM CAP			Light brown moderately hard SILT/SAND/CLAY mix., wet.	6
7	UNDISTURBED NATIVE SOIL		6'-6.3'- 10 blows 9.6 ppm	Brown and red silty CLAY, tar-like odor.	7
8				BASE OF WELL AT 6.3' END OF EXPLORATION AT 6.3'	8
9					9
10					10
11					11
12					12
13					13
14					14
15					15
16					16
17					17
18					18
19					19
20					20
21					21
22					22
23					23
24					24
25					25

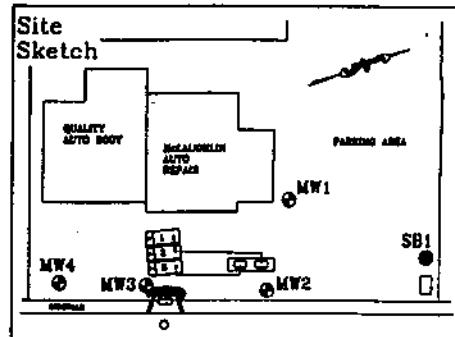
WELL NUMBER MW3

DEPTH IN FEET	WELL CONSTRUCTION	NOTES	BLOWS PER 6" OF SPOON & PID READINGS	DESCRIPTION/SOIL CLASSIFICATION (COLOR, TEXTURE, STRUCTURES)	DEPTH IN FEET
0		ROAD BOX			0
1		LOCKING WELL CAP			1
2		CONCRETE	0'-2'- 1,4,7,5 112 ppm	Brown fine SAND with orange varves, dry, slight petroleum odor.	2
3		NATIVE BACKFILL			3
4		BENTONITE	2'-4'- 2,1,3,4 1186 ppm	Brown fine well graded SAND over SILT layer, over fine red GRAVEL and SAND, strong petroleum odor.	4
5		WELL RISER		Brown very coarse SAND and GRAVEL with silt, saturated, strong pet. odor, sheen. 5.0' WATER TABLE	5
6		SAND PACK	4'-5.5'- 2,1,21,0 1069 ppm		6
7		WELL SCREEN		BASE OF WELL AT 5.5' END OF EXPLORATION AT 5.5'	7
8		BOTTOM CAP			8
9		BEDROCK			9
10					10
11					11
12					12
13					13
14					14
15					15
16					16
17					17
18					18
19					19
20					20
21					21
22					22
23					23
24					24
25					25

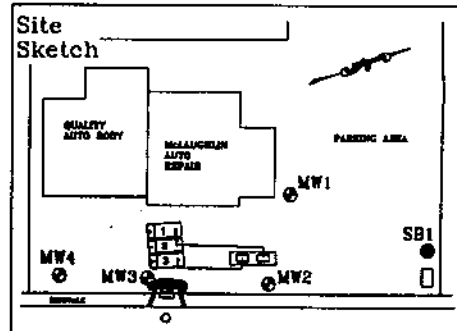
DEPTH IN FEET	WELL CONSTRUCTION	NOTES	BLOWS PER 6" OF SPOON & PID READINGS	DESCRIPTION/SOIL CLASSIFICATION (COLOR, TEXTURE, STRUCTURES)	DEPTH IN FEET
0		ROAD BOX			0
1		LOCKING WELL CAP			1
2		CONCRETE BACKFILL	0'-2'- 4,15,10,10 188 ppm	<u>Pavement</u> Brown SAND and CLAY over coarse gray sand over black cinder, over brown fine sand, old petroleum odor.	2
3		BENTONITE			3
4		WELL RISER	2'-4'- 4,4,3,4 469 ppm	Gray SILT with some clay and coarse sand stained, old petroleum odor. strong petroleum odor.	4
5		SAND PACK	4'-6'- 2,3,1,2 660 ppm	Dark gray silty SAND with fine gravel, strong pet. odor.	5
6		WELL SCREEN	6'-6.8'- 6,20 729 ppm	Brown stained SAND and SILT over light brown sand, saturated.	6
7		BOTTOM CAP			7
8		UNDISTURBED NATIVE SOIL		BASE OF WELL AT 6.8' END OF EXPLORATION AT 6.8'	8
9					9
10					10
11					11
12					12
13					13
14					14
15					15
16					16
17					17
18					18
19					19
20					20
21					21
